Accessibility Audit

Westfield Primary School

Clayton Crescent,

19/06/2020

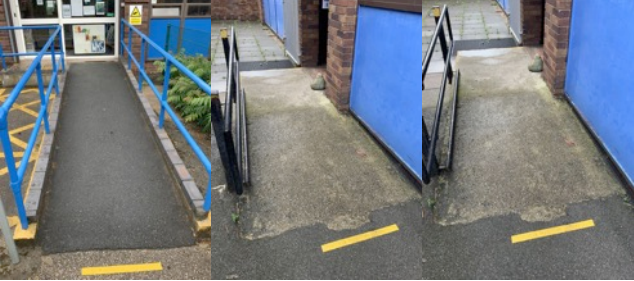
</div> <div style="display: flex; justify-content: space-around; align-items: center; margin-top: 5px;"> Appendix 15 Appendix 16 Appendix 17 </div>

3.1 - Wide enough and suitably graded? Is there colour contrast to the surface of the ramp?	D	The external ramps including leading up to the main entrance do not have colour contrast to indicate the presence of a gradient. Note, a yellow strip to the start of a ramp can cause potential confusion as it can indicate a step. This is important to ensure that the presence of a gradient are indicated. Gradients that take someone by surprise could cause a potential stumbling hazard.
<div style="display: flex; justify-content: space-around; align-items: center;">

3.1	<p>The external ramps including leading up to the main entrance do not have colour contrast to indicate the presence of a gradient. Note, a yellow strip to the start of a ramp can cause potential confusion as it can indicate a step.</p> <p>This is important to ensure that the presence of a gradient is indicated. Gradients that take someone by surprise could cause a potential stumbling hazard.</p>	<p>Appropriate colour contrast should be added to the surface of the ramps.</p> <p>According to BS8300 - The surface of a ramp should contrast visually with the landings and the edge protection so that its presence is discernible by people who are blind or partially sighted.</p> <p>To maintain traction, a sloping surface should have a higher slip resistance than an equivalent level surface. The steeper the slope, the greater the friction needed to maintain contact with the ground without slipping. Surface materials should be chosen to be durable and easy to maintain, and should be slip-resistant when wet, to allow for rain and other environmental factors.</p>	OG / M

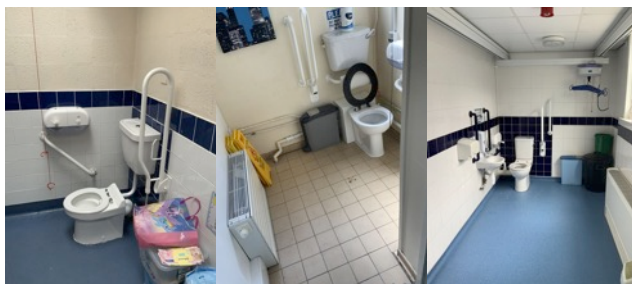
Appendix 55

The visitors accessible WC which is located near the reception area has dimensions which are not compliant. Many wheelchair users are likely to find this facility difficult to use. It was recommended in previous access audit reports that this facility be potentially enlarged by utilising the toilet adjacent.

The accessible WC off the library could do with a refurbishment as it is not correctly laid out. All of the fittings are not contrasted, limited grab rails, no hand wash basin within reach of toilet, no mirror or hand drier.
