Accessibility Audit

Westfield Primary School

Clayton Crescent,

19/06/2020

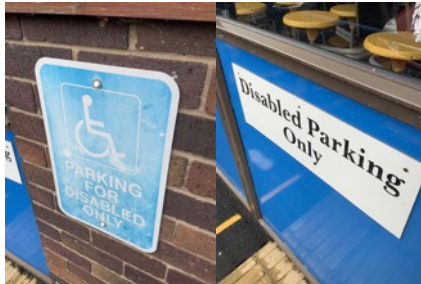
Appendix 10

It would be preferable for the signs in front of the accessible parking spaces to be pictorial. The existing sign has faded and should refer to blue badge holders rather than disabled. Signage indicating where the accessible parking spaces are located are not deemed required.

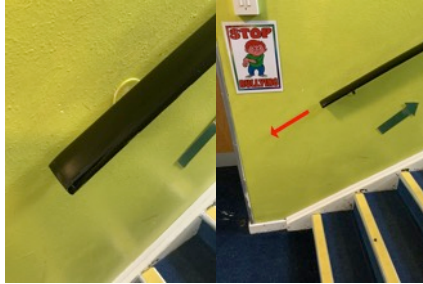
Appendix 37

10.3 - Suitable handrails on each side? Do handrails extend 300mm beyond the first and last step pitch-line? Are handrails suitably colour contrasted?	B	The stairwell near the sensory room has handrails which are not of the correct oval profile. They also do not extend 300mm beyond the first step pitch line.

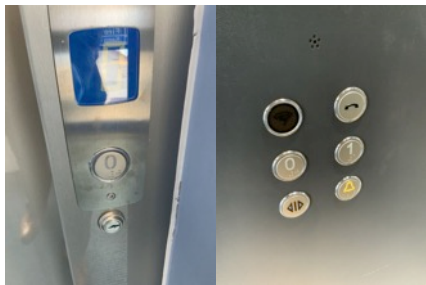
Appendix 42

The lift buttons feature tactile and braille which will aid people with impaired vision.

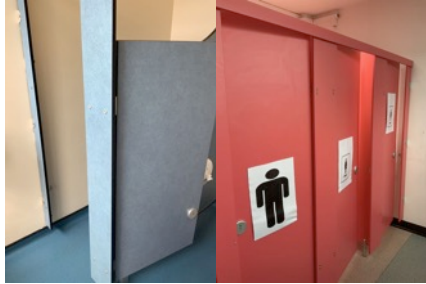
Appendix 52

As highlighted within the previous access audit reports, numerous cubicle doors are not colour contrasted against the side panels.

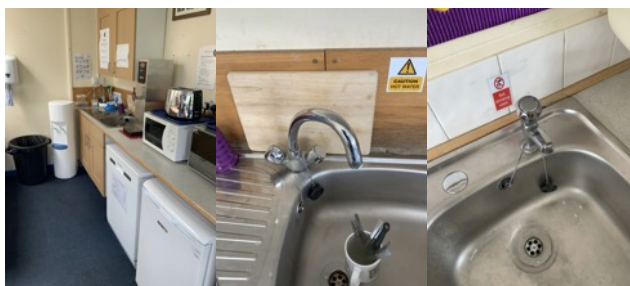
Appendix 68

<p>14.8 - Do staff and general kitchenette areas have a lever tap to accommodate people with dexterity impairments? Are there split height work surfaces available? Are there lever taps within the classrooms?</p>	<p>D</p>	<p>The kitchenette within the staff room does not feature lever taps to aid people with dexterity impairments. There are also no split height work surfaces to aid wheelchair users and people of short stature. The taps within the classrooms should be changed to lever style.</p>
---	----------	---

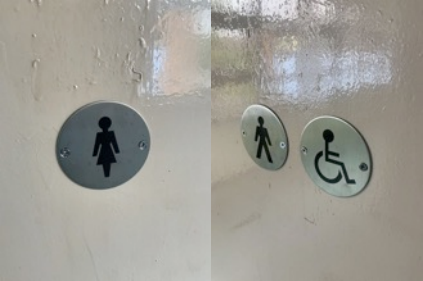
<p>15.1 - Overall layout of school reasonably clear and logical? Is there signage available in Braille and tactile?</p>	<p>C</p>	<p>As highlighted within the previous access audits, the school could do with a signage review. There is no tactile or braille signage provided within the school to aid people with impaired vision. There is very limited pictorial signage to aid people with learning and developmental impairments. Whilst the latest BS8300 revision has downplayed the requirement for Braille, it has highlighted the importance of pictorial signage.</p>
<p>15.2 - On entering the reception area, are signs designed and located to convey information to visitors with sight impairments and wheel chair users with lower eye levels?</p>	<p>Yes / N/A</p>	<p>Visitors are always escorted hence deemed reasonable to retain.</p>
<p>15.3 - Are standard toilet facilities suitably signed? On approach and on the actual entrances? Are the locations of the accessible WC facilities suitably identified and located? Does signage have the International Symbol of Access? (Wheelchair</p>	<p>C</p>	<p>There is no tactile or braille signage provided on the toilet doors. There is no signage to indicate where the accessible WCs are located.</p>

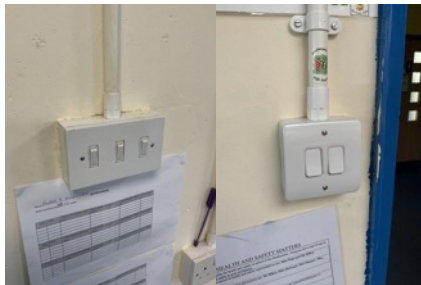
Appendix 74

The majority of the light switch plates are not suitably colour contrasted against their background. This is due to having white light switch plates seen against pale walls. This was highlighted in both of the previous access audit reports.
